HYDRAULIC MODEL INVESTIGATION

TECHNICAL REPORT NO. 188-1

Blue River Channel Improvement Project at Kansas City, Missouri

CONDUCTED BY
DIVISION HYDRAULIC LABORATORY
U. S. ARMY CORPS OF ENGINEERS
NORTH PACIFIC DIVISION
BONNEVILLE, OREGON

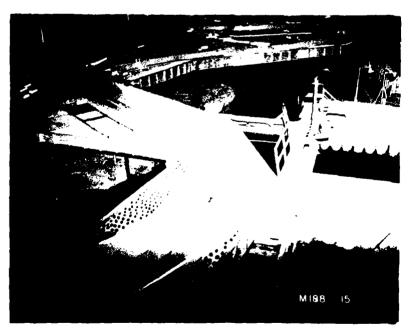
Looking downstream

Looking upstream

Photograph 1. Blue River Channel model (before final roughness adjustment for verification, bridge superstructure removed to show piers)

- 5. Constructed to a scale ratio of 1:40, the model included the 3,443-foot-long concrete-lined channel section adjacent to the Armco rolling mill, 4,322 feet of rock shell channel, 609 feet of grouted riprap channel followed by 2,397 feet of rock shell and earth-cut channel, and the overbank flow area in the Armco rail yard adjacent to the concrete channel. The reach modeled contained 11 bridges and the Independence Avenue overpass in the rail yard. The area was bounded by high ground and buildings of the steel mill that acted as principal flow boundaries. The main study area was at bridges B-5 and B-6, which were located at the downstream end of the concrete channel. The bridges had large skewed piers in the channel and were located in the middle of a that extended into the riprapped channel downstream. Details of the model as originally studied are shown on photographs 1 through 11 and plates 2 and 3.

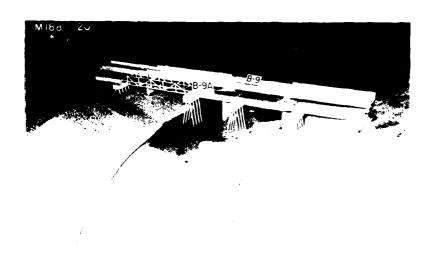
Photograph 3. Bridges B-9 and B-9A and adjacent channel (before final roughness adjustment for verification)

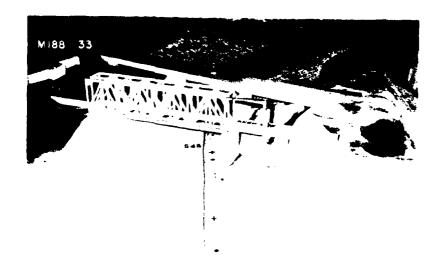
After verification of channel

Before verification of channel

Photograph 8. Bridges B-5 and B-6 and adjacent channel

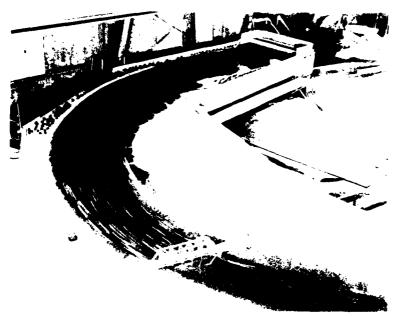
Upstream from bridge B-10

From bridge B-10 to B-8

Photograph 14. Flow conditions with discharge of 35,000 cfs and Missouri River at 10-year discharge

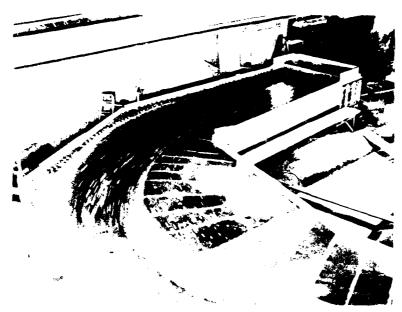
Upstream from bridge B-10

From bridge B-10 to B-8

Photograph 17. Flow conditions with discharge of 42,000 cfs and Missouri River at 10-year discharge

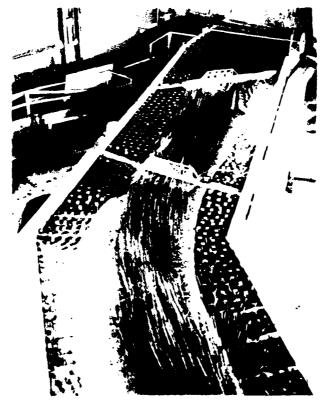
From bridge B-5 to B-4

At bridges B-4 and B-3

Photograph 19. Flow conditions with discharge of 42,000 cfs and Missouri River at 10-year discharge

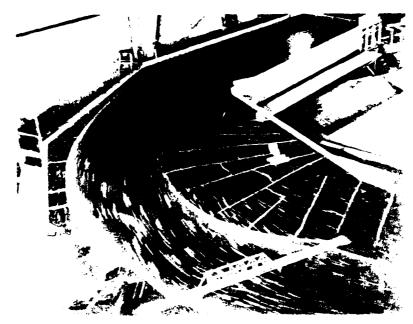
Upstream from bridge B-10

From bridge B-10 to B-8

Photograph 20. Flow conditions with discharge of cfs and Missouri River at 10-year discharge

bridges B-6 and B-7 was not overtopped. Flow in the curves near the upstream end of the floodwall near bridges B-7 and B-7A was superelevated 1.4 and 0.8 feet, respectively. Localized areas of supercritical flow occurred around the main in-channel piers of bridges B-5 and B-6. Overbank flow initially began with a discharge of about 37,000 cfs and occurred along the left bank of the channel between stations 470+00 and 490+00 (bridge B-10). Extensive overbank flooding through the rail yard on the right bank of the channel between stations 490+00 and 528+00 (bridge B-7) occurred with a discharge of approximately 40,000 cfs. Flow conditions with a discharge of 42,000 cfs (50-year flood) are shown on plates 8 and 9 and photographs 17 through 19. The entire length of the floodwall at the rolling mill was overtopped. With a discharge of 52,800 cfs (100-year flood), the entire area modeled was flooded. As shown on plates 10 and 11, water overtopped the right bank near station 487+00 (just upstream from bridge B-10) with velocities of 7 to 8 fps, flowed overland through the rail yard with velocities up to 11 fps, and reentered the main channel at numerous locations between stations 500+00 and 545+00. Photographs 20 through 22 show flow conditions along the channel reach.

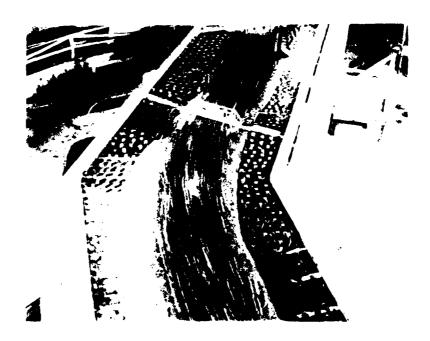
From bridge B-5 to B-3

At bridge B-4

Photograph 22. Flow conditions with discharge of 52,800 cfs and Missouri River at 10-year discharge

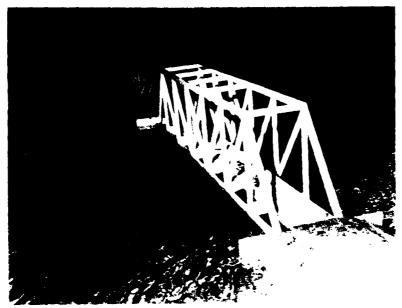
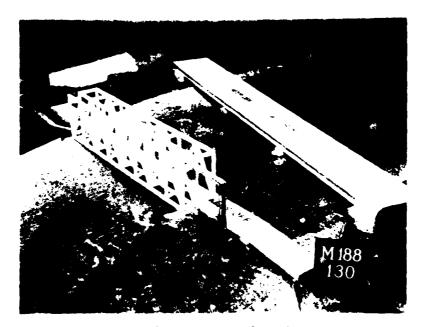
Bridge B-4

Bridges B-5 and B-6

Photograph 23. Flow conditions with discharge of 35,000 cfs and Missouri River at 10-year discharge

- 14. With the design discharge and tailwater, flow impinged on bridges B-4, B-6, B-7, B-7A, and B-10. Flow conditions at bridges B-4, B-5, B-6, and B-10 are shown on photographs 23 and 24. Plates 19 through 25 show water surface cross sections both up and downstream from bridges B-4, B-5, B-6, B-7, B-7A, B-8, and B-10 for various discharges with the design tailwater condition. Bridge head loss from the upstream side of B-6 to the downstream side of B-5 with the design discharge and tailwater was 2 feet and increased to 4.4 feet with the minimum tailwater condition.

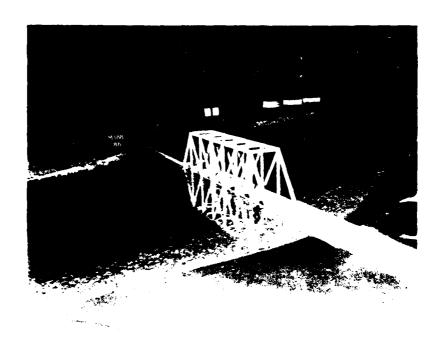
Bridge B-10

Photograph 24. Flow conditions with discharge of 35,000 cfs and Missouri River at 10-year discharge

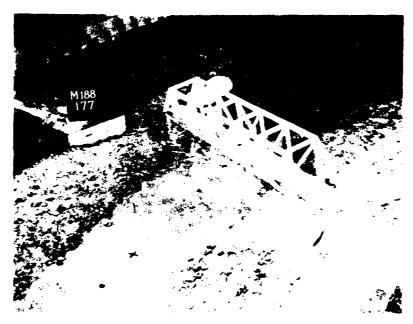
Photograph 30. Bridges swept from piers into channel in upright position. Discharge of 35,000 cfs with Missouri Fiver at 10-year discharge.

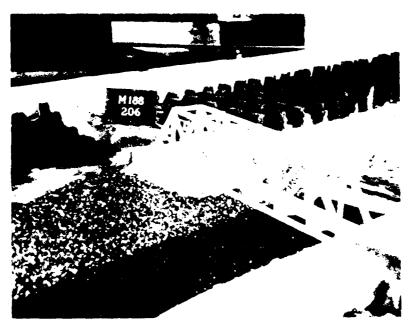
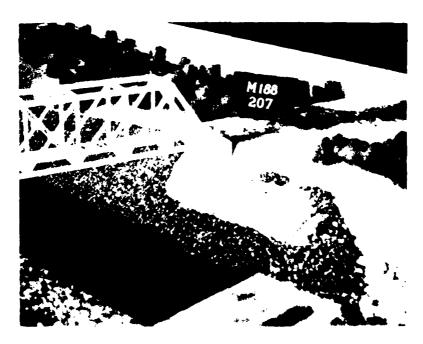
Photograph 31. Failure of 18-inch riprap at left abutment of bridge B-4 after a discharge of 54,000 cfs with minimum tailwater

$(D_{50}=11.5 \text{ inch})$, 21-inch $(D_{50}=12.6 \text{ inch})$, and 24-inch $(D_{50}=15.9 \text{ inch})$. With all three sizes tested, riprap failure occurred near the left abutment of bridge B-4 (photograph 31). The discharges at which the failure occurred were 54,000, 70,000, and 71,000 cfs for the respective 18-, 21- and 24-inch riprap sizes.

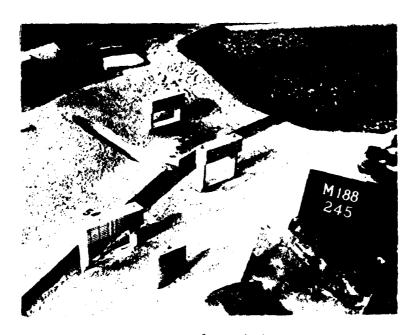
Photograph 33. Piers of bridges B-5 and B-6. Looking downstream, bridge B-6 in foreground.

upstream of bridge B-6 were determined with the existing bridges (plate 37) and with various combinations of bridge modifications including (1) improvement (photograph 33) and removal of piers at bridges B-5 and B-6, (2) addition of end spans at bridge B-4 (photograph 34), and (3) addition of streamlined cowls on the upstream bottom girder of the bridges. Plates 38 through 44 and photographs 35 through 43 show water surface profiles and flow conditions with the various improvements tested in the model. As shown in table 1, the largest decrease in water level upstream of bridge B-6 (2.2 feet at design discharge) resulted when the piers of bridges B-5 and B-6 were removed from the flow. Modification of the B-5 and B-6 bridge piers was also relatively successful in decreasing water levels upstream of bridge B-6. Neither addition of end spans to bridge B-4 nor streamlining the upstream bottom girder of the three bridges with 3.5 feet radius quarter-round sections were effective. Cross sectional velocity distribution through bridges B-5 and B-6 with the design discharge (design and minimum tailwater) with bridge piers removed from the flow and with the bridge B-6 pier improved is shown on plates 46 through The water surface profiles along both sides of bridges B-5 and B-6 bridge piers with the B-6 pier improvement are shown on plates 49 and 50 for the design discharge condition with design and minimum tailwater, respectively. Plate 51 illustrates the bridge B-4 cross-sectional water surface profile with end spans added to the bridge.

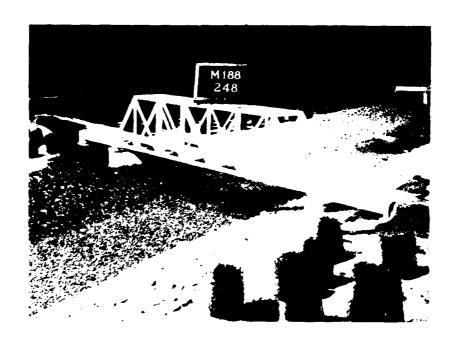
Photograph 34. Revised bridge B-4 (end spans added) looking downstream

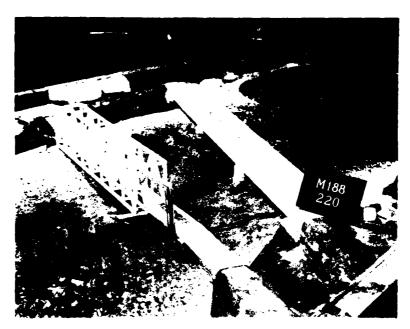
Photograph 36. Flow conditions at bridges B-5 and B-6 with revised piers of bridge B-5 and existing piers of bridge B-6. Missouri River at 10-year discharge.

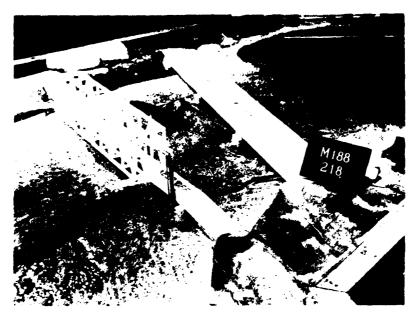
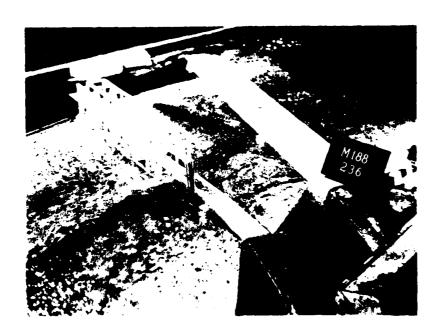
Photograph 37. Flow conditions at bridges B-5 and B-6 with revised piers of bridge B-6. Missouri River at 10-year discharge.

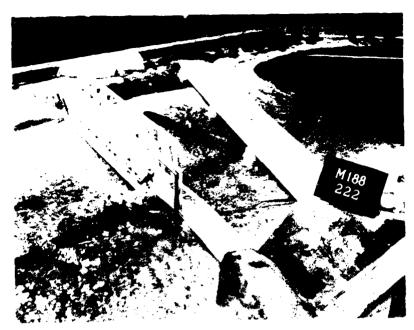
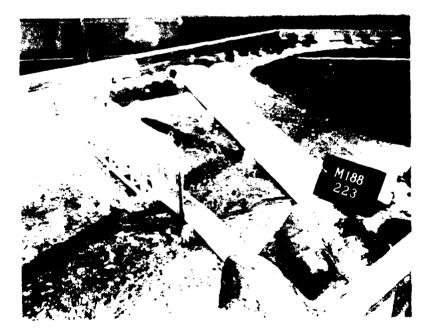
Photograph 38. Flow conditions at bridges B-5 and B-6 with revised piers of both bridges. Discharge of 35,000 cfs with Missouri River at 10-year discharge.

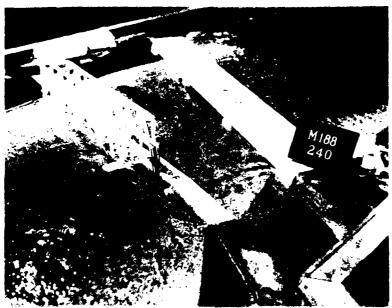
Photograph 39. Flow conditions at bridges B-5 and B-6 with revised piers of both bridges. Discharge of 52,800 cfs with Missouri River at 10-year discharge.

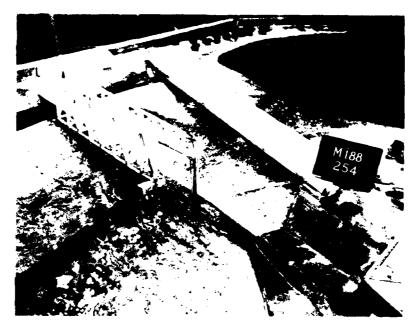
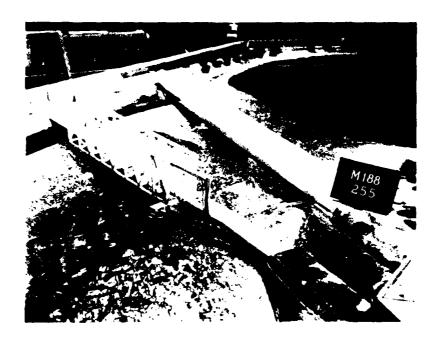
Photograph 40. Flow conditions at bridges B-5 and B-6 with existing piers, discharge of 42,000 cfs with Missouri River at 10-year discharge

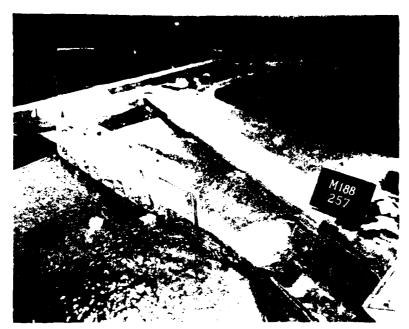
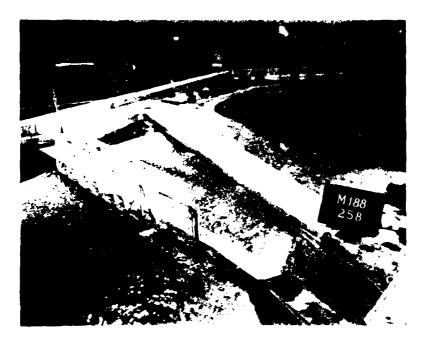
Photograph 41. Flow conditions at bridges B-5 and B-6 with existing piers. Discharge of 52,800 cfs with Missouri River at 10-year discharge.

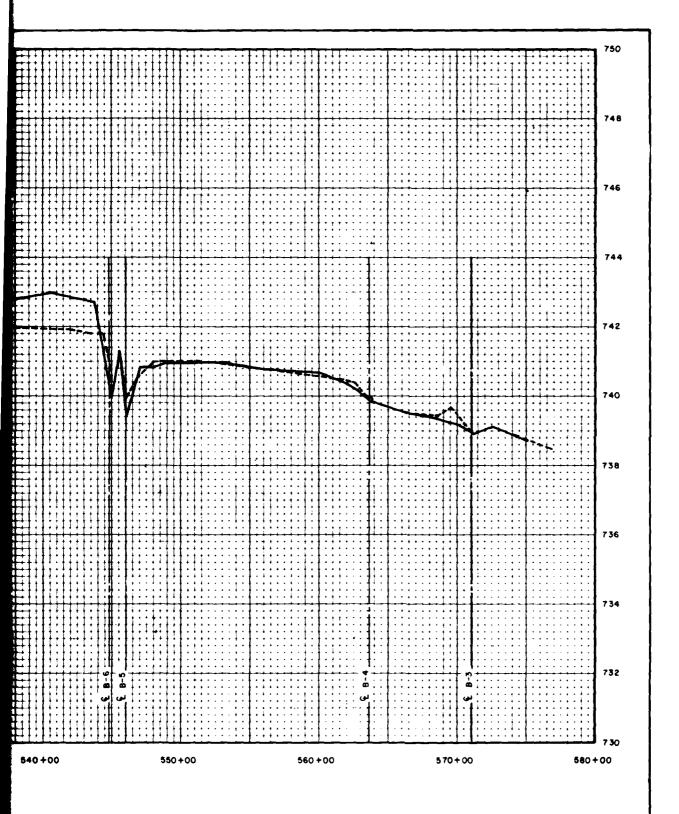
WATER SURFACE PROFILE ALONG CENTER LINE VERIFICATION OF CHANNEL

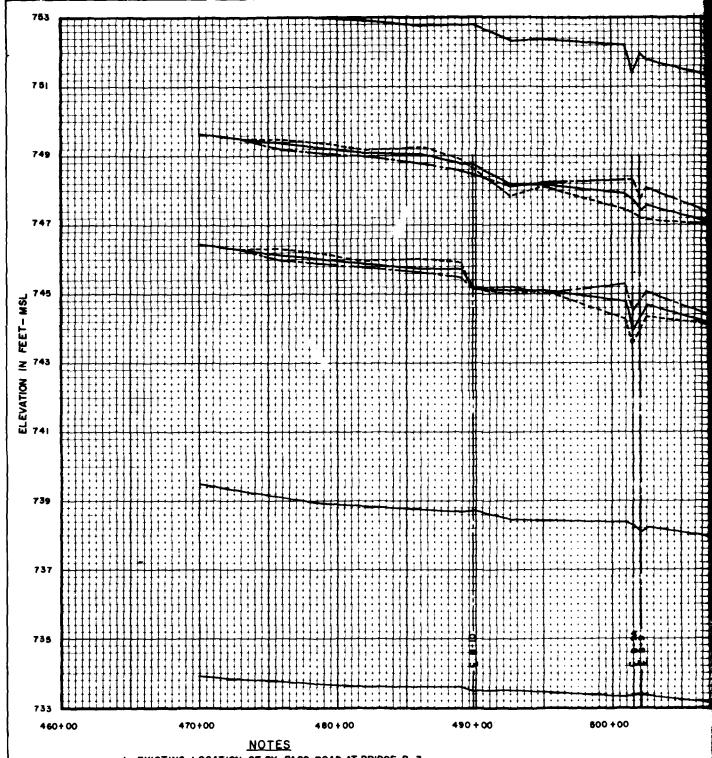
- L EXISTING LOCATION OF BY-PASS ROAD AT BRIDGE B-3
- 2. ORIGINAL DESIGN PIER 2 BRIDGE B-6
- 3. RAILROAD TRESTLE ALONG RIGHT BANK STATION 533+00 TO 539+00
- 4. TOP OF WALL AT ELEVATION 744.0 BETWEEN BRIDGES B-7 AND B-6

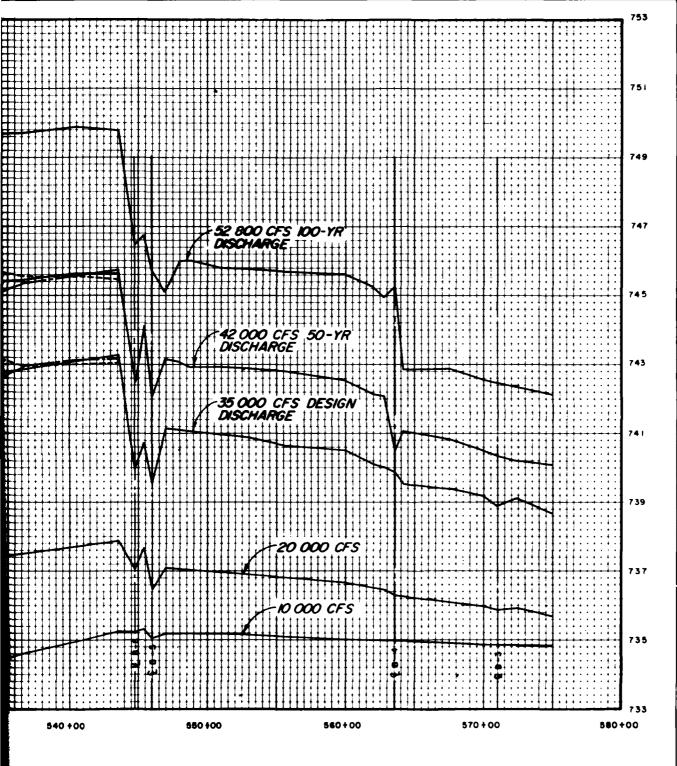
WATER SURFACE PROFILES
MISSOURI RIVER AT IO-YEAR DISCHARGE

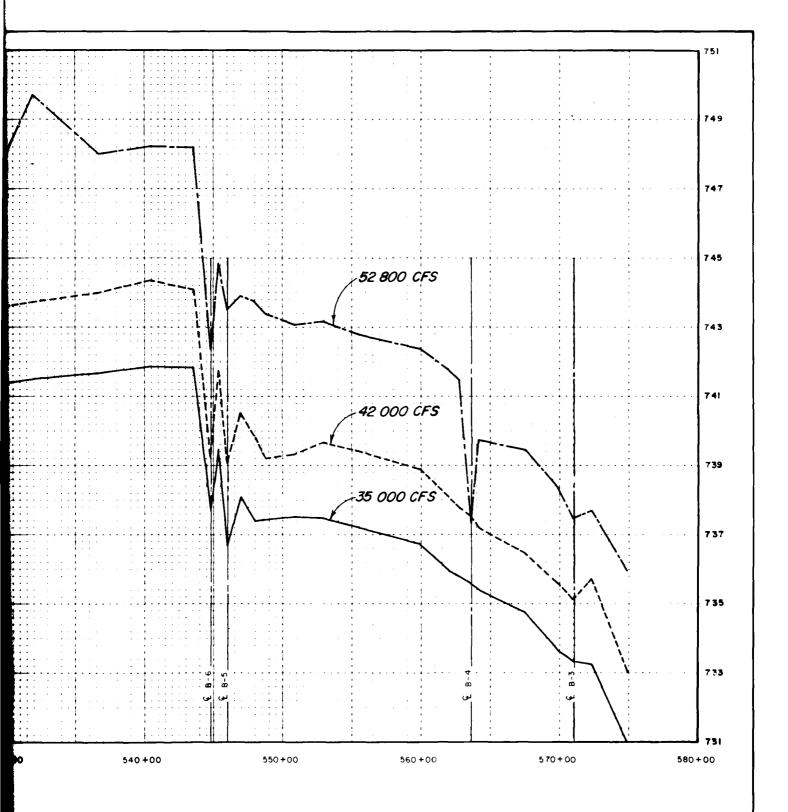
WATER SURFACE PROFILE ALONG CENTER LINE MINIMUM TAILWATER

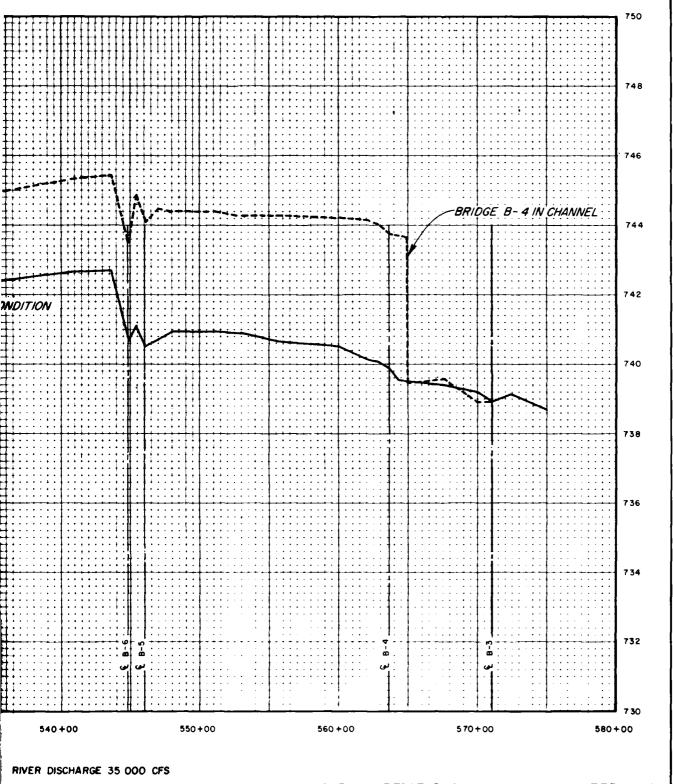
WATER SURFACE PROFILE ALONG CENTER LINE COLLAPSE OF BRIDGES B-4 AND B-10 INTO CHANNEL BRIDGES LYING ON SIDES

- 16. Due to the flow impingement and a potential for debris buildup on the bridges, tests were accomplished to determine the effect of failures of bridge B-4 and B-10 upon channel flow conditions. Tests were accomplished with the bridges either on their side (photograph 27) or in an upright position (photograph 28) within the channel. Flow conditions in the immediate vicinity of the bridges with the design discharge and tailwater are shown in photographs 29 and 30. Water surface profiles with the bridges either on their sides or upright in the channel are shown on plates 30 and 31, respectively.

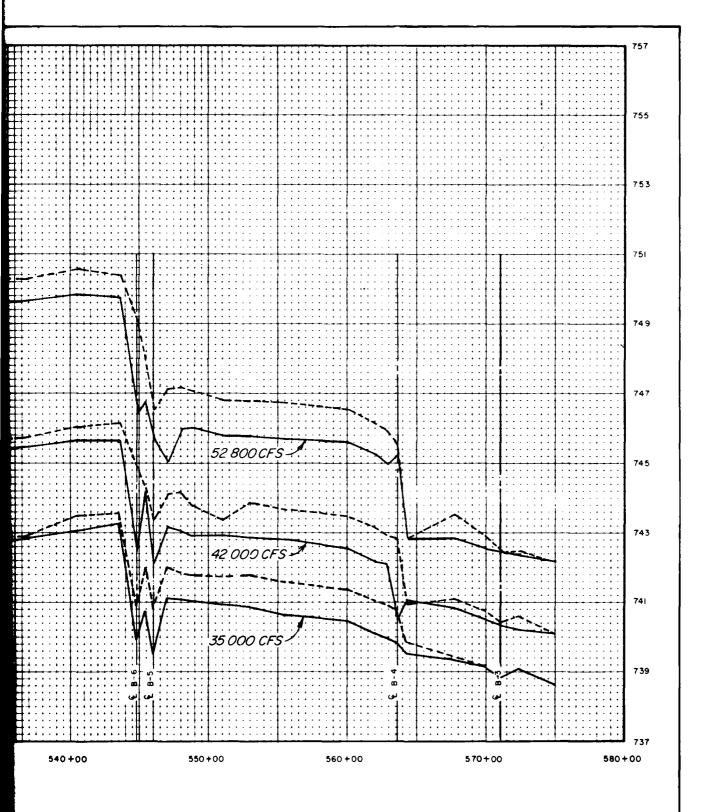
PLATE 31

WATER SURFACE PROFILE ALONG CENTER LINE COLLAPSE OF BRIDGES B-4 AND B-10 INTO CHANNEL BRIDGES UPRIGHT

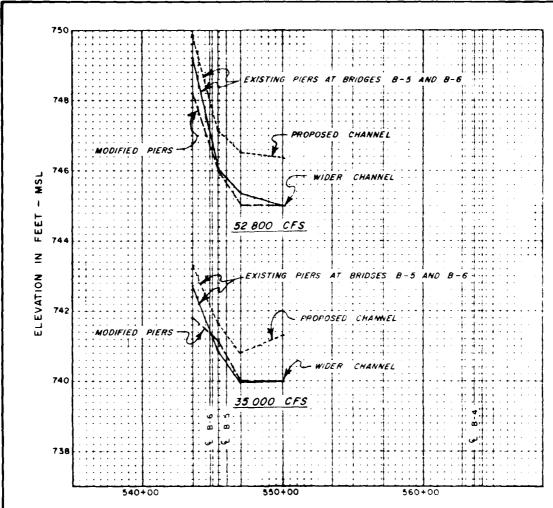
WATER SURFACE PROFILE ALONG CENTER LINE

EFFECT OF WIDER DOWNSTREAM

CHANNEL AT BRIDGES 8-5 AND 8-6

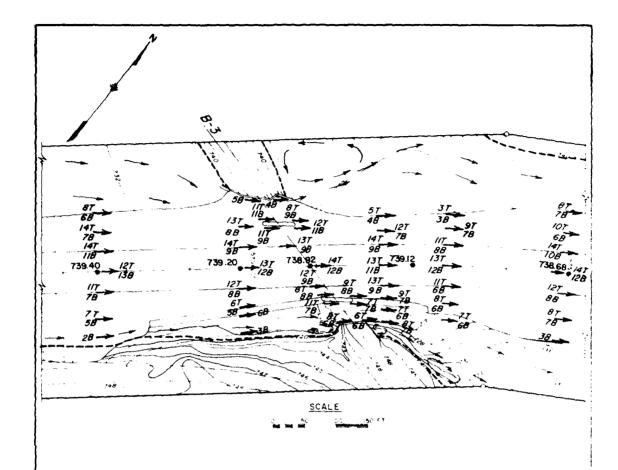
EXISTING ARMCO ROADWAY

FLOW CONDITIONS AT
BRIDGE B-3
RIVER DISCHARGE 35000 CFS
DESIGN TAILWATER

- 20. The original channel design at bridge B-3 included relocation of an existing Armco mill roadway passing beneath the right span of the bridge (photograph 11). As shown on plates 33 and 34, the relocation had no appreciable affect on flow conditions and was therefore not included in the final design.

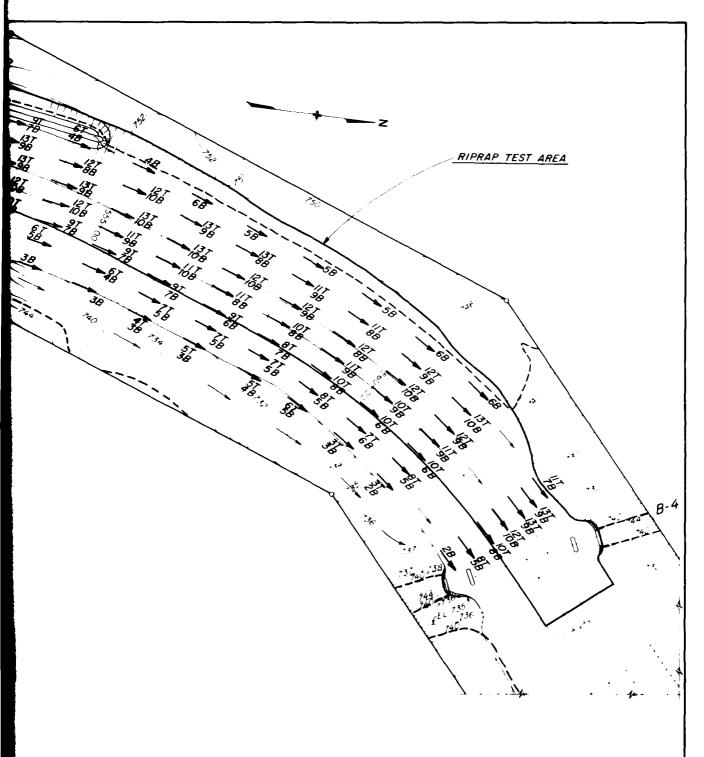
FLOW CONDITIONS
STATIONS 547+00 TO 563+00
REVISED RIPRAPPED CHANNEL
RIVER DISCHARGE 42 000 CFS
DESIGN TAILWATER

- 21. The original design was modified between stations 546+55 and 552+64 during the model studies by extending the concrete section from station 546+55 to station 546+85, by shortening the transition between the concrete section and the riprap section from 609 feet to 125 feet, by reducing the height of the left bank slope to only the elevation of the existing sewer pipe, and by replacing the grouted riprap with loosely placed riprap (plate 35 and photograph 32). The 24-inch-thick riprap blanket (21-inch rock on the upstream 100 feet and 18-inch rock on the remainder) was placed over a 24-inch bed of pea gravel to simulate a filter to evaluate the potential for riprap failure resulting from leaching of the filter. Previous tests of 18-inch riprap in the transition section indicated that the riprap would withstand discharges up to 71,000 cfs (paragraph 18). With a discharge of 42,000 cfs

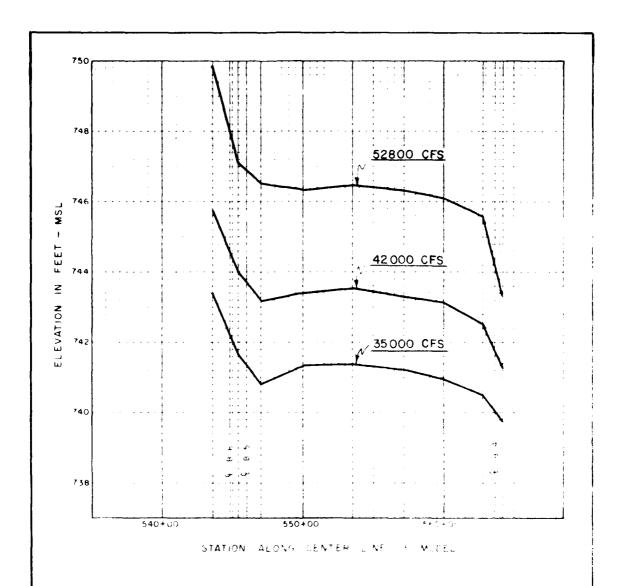
WATER SURFACE PROFILE ALONG CENTER LINE EXISTING PIERS AT BRIDGES B-5 AND B-6 EXISTING BRIDGE B-4

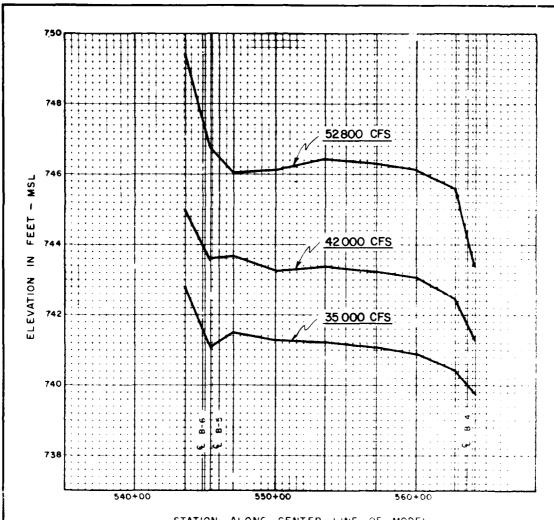
WATER SURFACE PROFILE ALONG CENTER LINE MODIFIED PIERS AT BRIDGE B-5

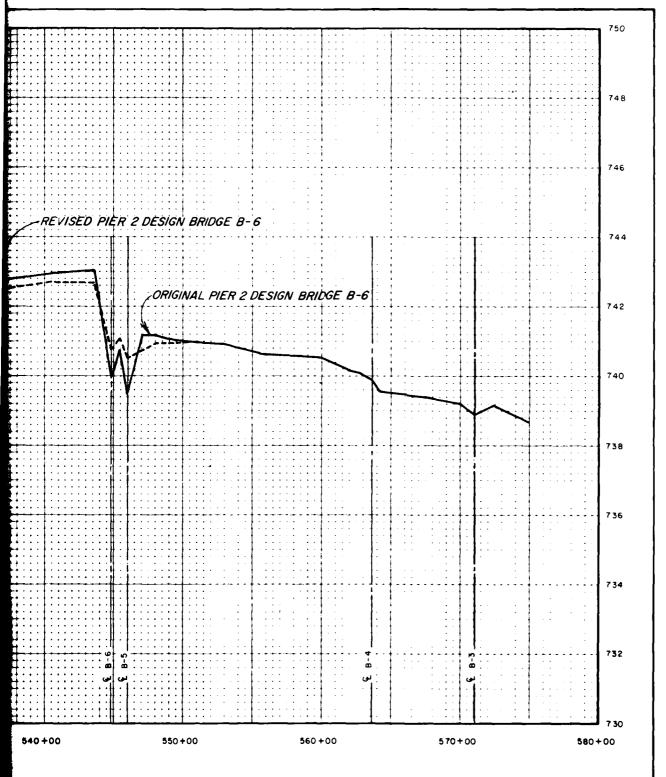
VER DISCHARGE 35 000 CFS

WATER SURFACE PROFILE ALONG CENTER LINE EFFECT OF MODIFIED PIER 2 BRIDGE B-6

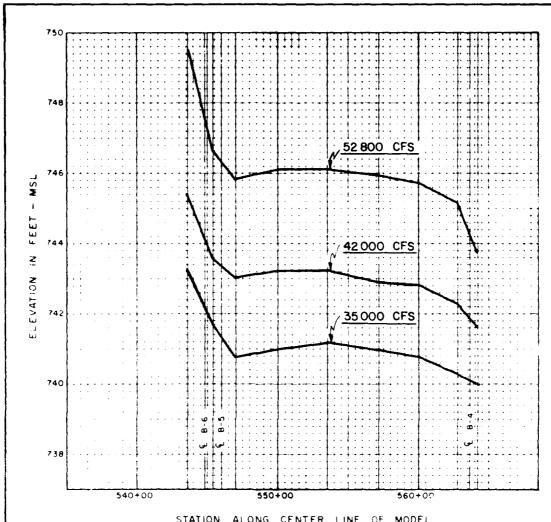
WATER SURFACE PROFILE ALONG CENTER LINE EXISTING PIERS AT BRIDGES B-5 AND B-6 REVISED BRIDGE B-4

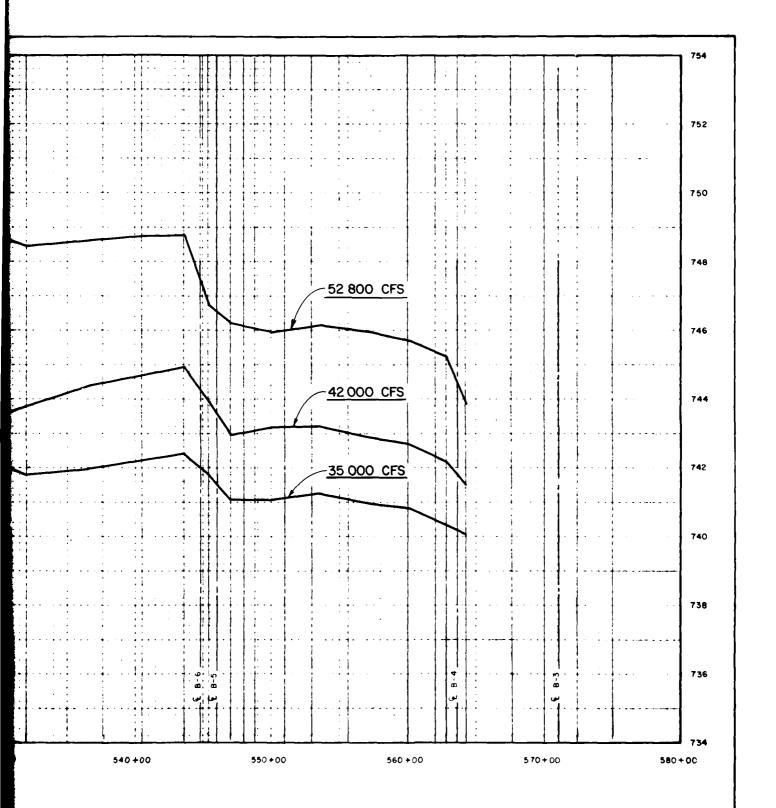
WATER SURFACE PROFILE ALONG CENTER LINE MODIFIED PIERS AT BRIDGES B-5 AND B-6 REVISED BRIDGE B-4

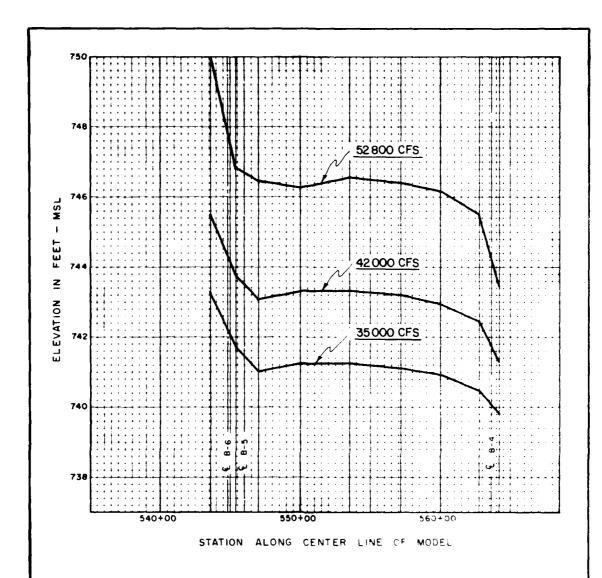
WATER SURFACE PROFILE ALONG CENTER LINE EXISTING PIERS AT BRIDGES B-5 AND B-6 COWLED BEAMS ON BRIDGES B-4, B-5, AND B-6

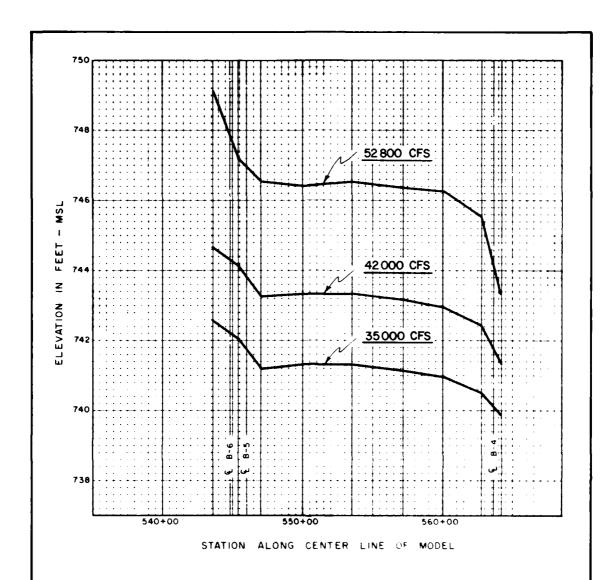
WATER SURFACE PROFILE ALONG CENTER LINE MODIFIED PIERS AT BRIDGES B-5 AND B-6 COWLED BEAMS ON BRIDGES B-4,B-5,AND B-6
